Property Address 123 School Road
City City State US Zip 12345
Phone (111)-111-1111 Fax (111)-111-1111

Inspector Name Jim Johnson
Company Name Advanced Inspections, Inc

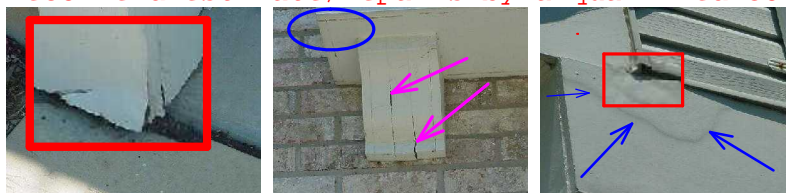
- 2. Acceptable Type: Vinyl siding
- 3. Defective Trim: Composite material Note: Damaged wood areas should be checked while doing the repair and replaced if wood rot is present.

1. Water damage to trim wood at either side of garage door from moisture wicking into the finished particle board. The surface is starting to delaminate. Recommend repair/replacement of the trim boards and silicone seal wood that is in contact with concrete to prevent wicking.
2. The wood window boxes have water damage and will require repair/replacement. The wood has started to separate at the supports and at the corners of the window boxes.
3. The trim board at the southwest corner of the porch has water damage due to water penetration and will require repair/replacement of the wood. The trim board extends out creating a ledge allowing water to collect on the top edge of the board and cause the wood to rot.

Recommend estimate/repairs by a qualified contractor.

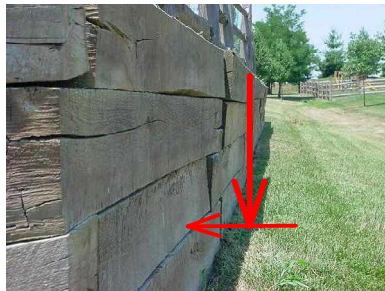
- 5. Acceptable Balcony: Concrete
- 6. Acceptable Porch: Concrete
- 7. Marginal Vegetation: Shrubs with some weeds
- 8. Marginal Retaining Walls: Railroad ties The wall is showing signs of movement, but appears to be stable at this time. A qualified contractor is recommended to evaluate and estimate repairs to maintain the wall.

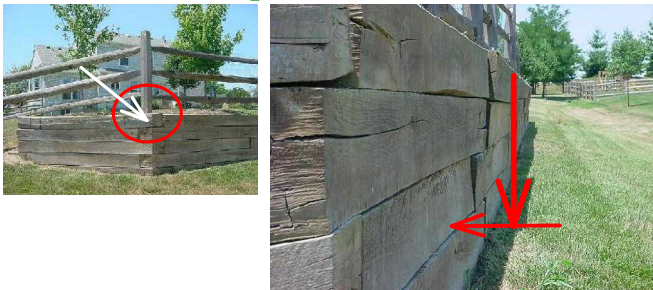
1. Vegetation: Shrubs with some weeds
2. Retaining Walls: Railroad ties The wall is showing signs of movement, but appears to be stable at this time. A qualified contractor is recommended to evaluate and estimate repairs to maintain the wall.

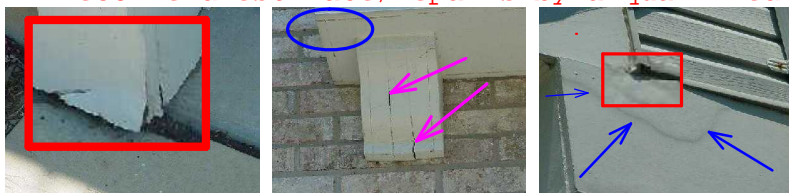
2. Trim: Composite material Note: Damaged wood areas should be checked while doing the repair and replaced if wood rot is present.

1. Water damage to trim wood at either side of garage door from moisture wicking into the finished particle board. The surface is starting to delaminate. Recommend repair/replacement of the trim boards and silicone seal wood that is in contact with concrete to prevent wicking.

2. The wood window boxes have water damage and will require repair/replacement. The wood has started to separate at the supports and at the corners of the window boxes.

3. The trim board at the southwest corner of the porch has water damage due to water penetration and will require repair/replacement of the wood. The trim board extends out creating a ledge allowing water to collect on the top edge of the board and cause the wood to rot.

Recommend estimate/repairs by a qualified contractor.

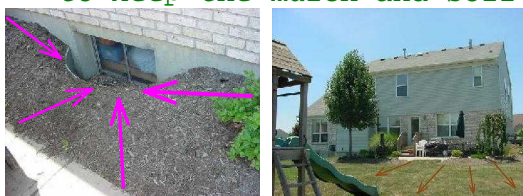
3. Deck: Treated wood The deck has been built below acceptable building standards and is not safe in its current state. Recommend further evaluation and estimate to bring deck up to an acceptable building standard.
4. Grading: Moderate slope The grade and landscaping materials are too high and extend above the window well at the Northeast rear of the home. Recommend that the grade be reduced or the metal window well soil retainer be replaced with a taller unit to keep the mulch and soil beds from washing into the well.
